# Pre-Shipment Inspection

| Product Name | 1. INTERIOR FLUSH DOOR 44 x 762 x 2743<br>2. INTERIOR FLUSH DOOR 44 x 914 x 2743<br>3. INTERIOR FLUSH DOOR 44 x 406 x 2438<br>4. INTERIOR FLUSH DOOR 44 x 610 x 2438<br>5. INTERIOR FLUSH DOOR 44 x 813 x 2438 | Inspection Date | 25/01/2023 |

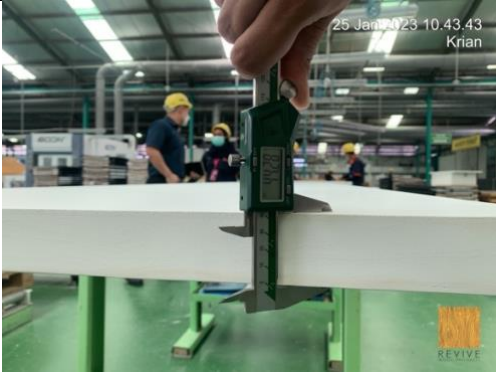
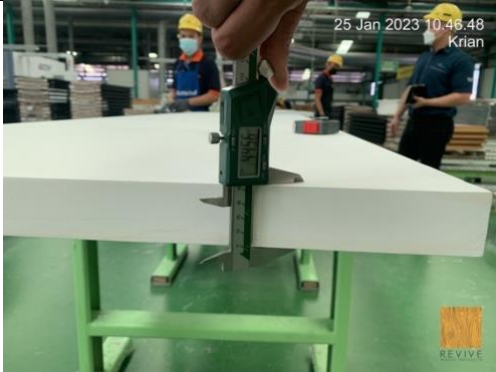
| Thickness | Thickness |

| Product Name | | INTERIOR FLUSH DOOR | | Dimensions (mm) | | | |
|---|---|---|---|---|---|---|---|
| 1 | 44.24 | 761 | 0 | 2742 | - | √ | OK |
| 2 | 44.56 | 762 | 1 | 2743 | - | √ | OK |
| 3 | 44.11 | 762 | 0.5 | 2743 | - | √ | OK |

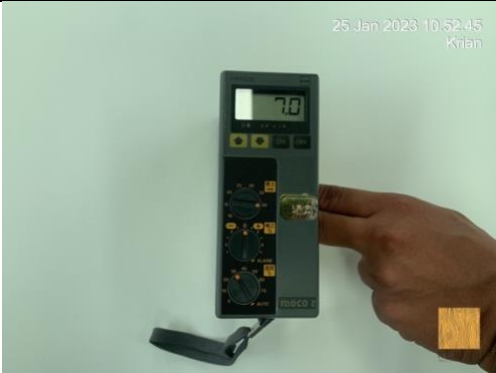
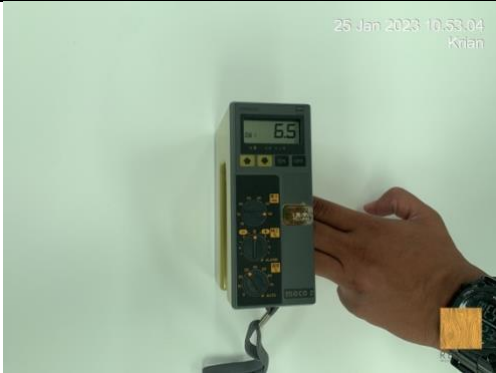
| Moisture Content | Moisture Content |

| Product | Specification | Actual Moisture Content (%) | | | Average (%) | Result |
|---|---|---|---|---|---|---|
| INTERIOR FLUSH DOOR<br>44 x 762 x 2743 | MC Product<br>(8-12%) | 7 | 8 | 7 | 6.8 | OK |

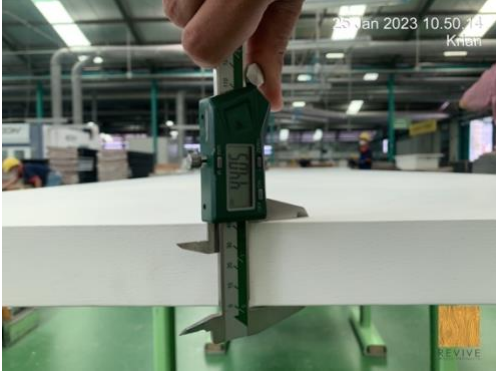
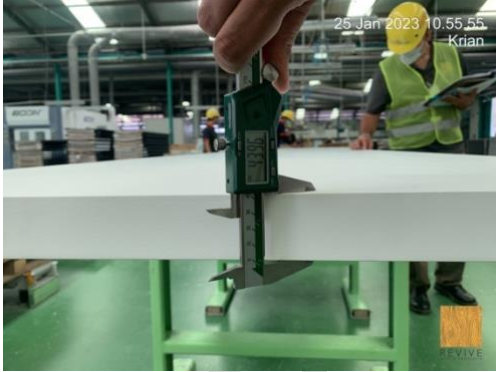
| Thickness | Thickness |

| Product Name | | INTERIOR FLUSH DOOR | | Dimensions (mm) | | | |
|---|---|---|---|---|---|---|---|
| 1 | 44.05 | 913.5 | 0 | 2743 | - | √ | OK |
| 2 | 43.96 | 914 | 1 | 2743 | - | √ | OK |
| 3 | 44.05 | 913 | 0 | 2743 | - | √ | OK |

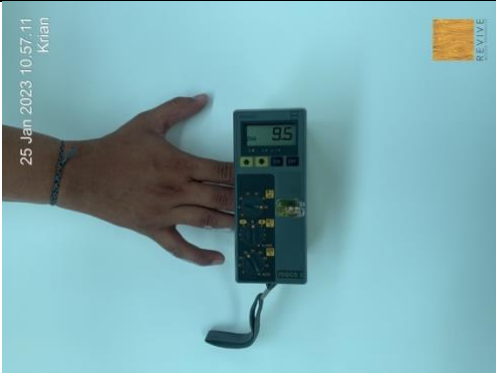
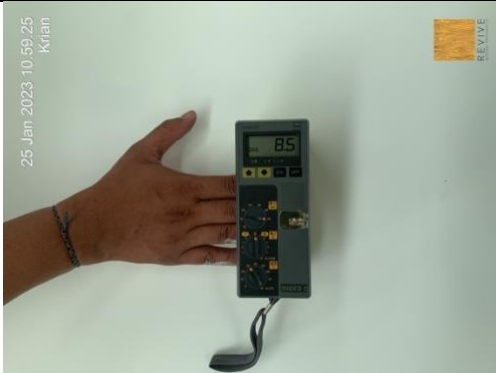
| Moisture Content | Moisture Content |

| Product | Specification | Actual Moisture Content (%) | | | Average (%) | Result |
|---|---|---|---|---|---|---|
| INTERIOR FLUSH DOOR<br>44 x 914 x 2743 | MC Product<br>(8-12%) | 6.5 | 6 | 6 | 7.9 | OK |

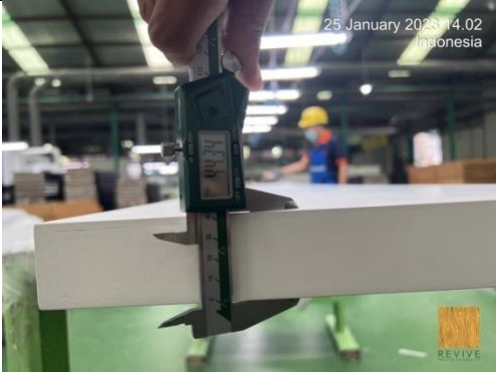
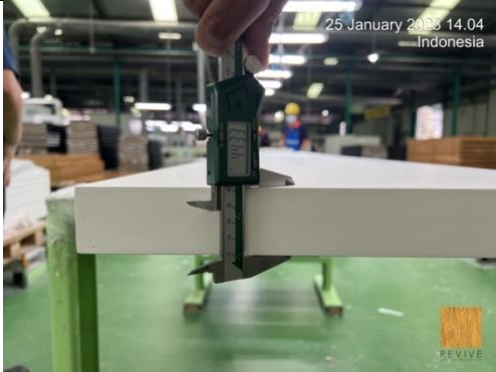
| Thickness | Thickness |

| Product Name | | INTERIOR FLUSH DOOR | | Dimensions (mm) | | | |
|---|---|---|---|---|---|---|---|
| 1 | 44.34 | 406 | 0 | 2438 | - | √ | OK |
| 2 | 44.33 | 406 | 0 | 2438 | - | √ | OK |
| 3 | 44.33 | 406 | 0 | 2438 | - | √ | OK |

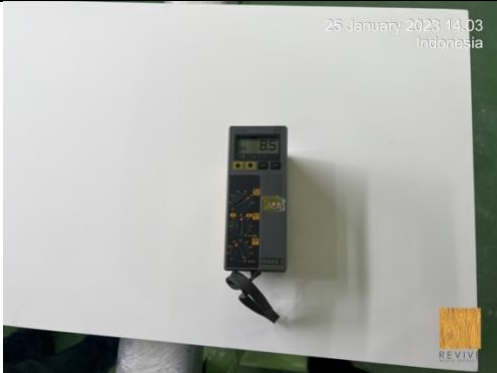
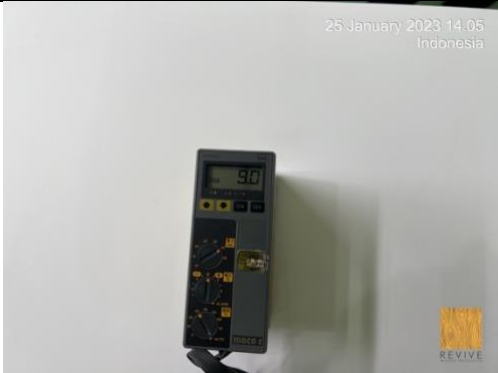
| Moisture Content | Moisture Content |

| Product | Specification | Actual Moisture Content (%) | | | Average (%) | Result |
|---|---|---|---|---|---|---|
| INTERIOR FLUSH DOOR<br>44 x 406 x 2438 | MC Product<br>(8-12%) | 8.5 | 8.5 | 8.5 | 8.4 | OK |

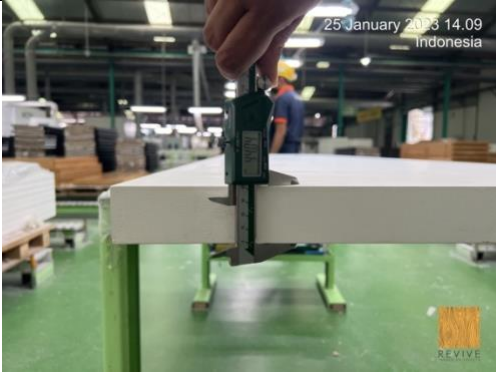
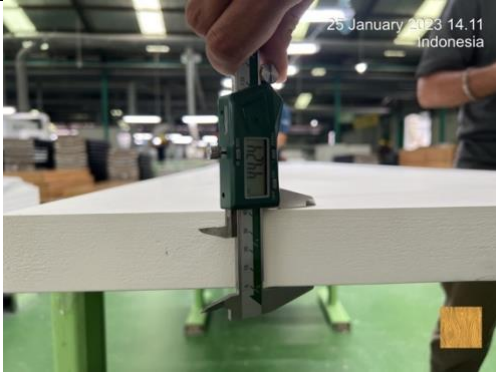
| Thickness | Thickness |

| Product Name | | INTERIOR FLUSH DOOR | | Dimensions (mm) | | | |
|---|---|---|---|---|---|---|---|
| 1 | 44.04 | 609 | 0 | 2438 | - | √ | OK |
| 2 | 44.24 | 609 | 0 | 2438 | Dent | √ | Repair |
| 3 | 44.18 | 609 | 1 | 2438 | Chipping | √ | Repair |

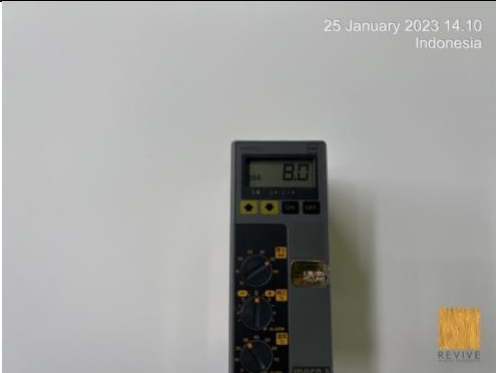
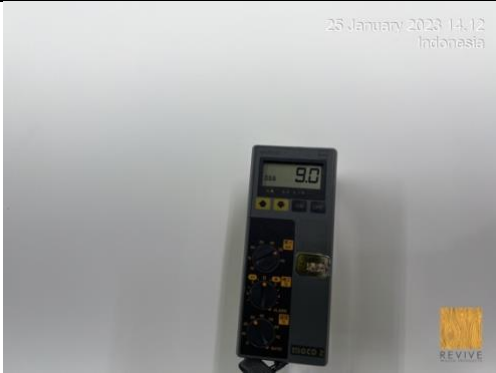
| Moisture Content | Moisture Content |

| Product | Specification | Actual Moisture Content (%) | | | Average (%) | Result |
|---|---|---|---|---|---|---|
| INTERIOR FLUSH DOOR<br>44 x 610 x 2438 | MC Product (8-12%) | 8 | 8 | 8 | 9 | OK |

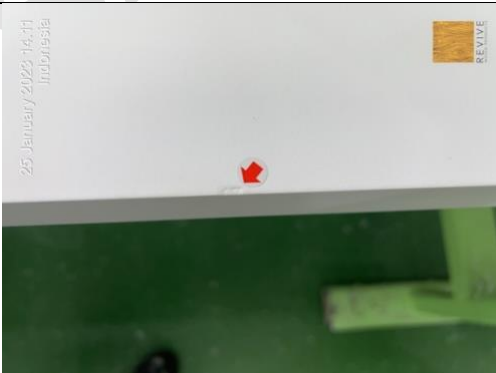
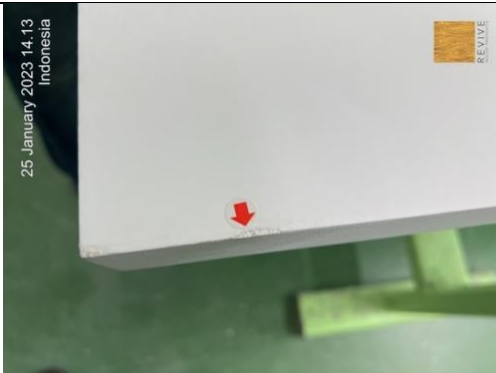
| Minor Defect | Minor Defect |

| Item | Description of Defects | Qty (pcs) | Remarks |
|---|---|---|---|
| 1 | Coating Crack | 1 | Minor |
| 8 | Dent | 1 | Minor |
| Total Defect | | Minor | 2 pcs |

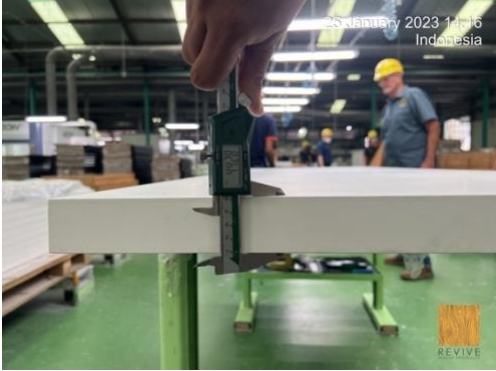
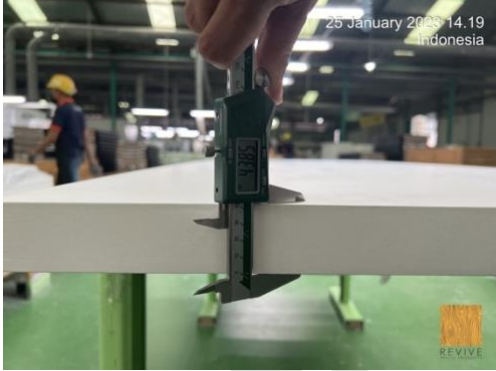
| Thickness | Thickness |

| Product Name | | INTERIOR FLUSH DOOR | | Dimensions (mm) | | | |
|---|---|---|---|---|---|---|---|
| 1 | 44.28 | 813 | 0 | 2438 | - | √ | OK |
| 2 | 43.85 | 813 | 1 | 2439 | - | √ | OK |
| 3 | 44.27 | 813 | 0 | 2438 | - | √ | OK |

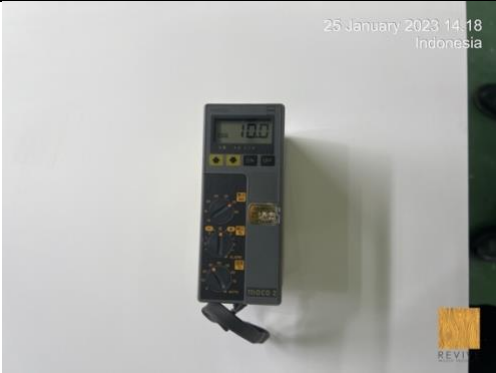
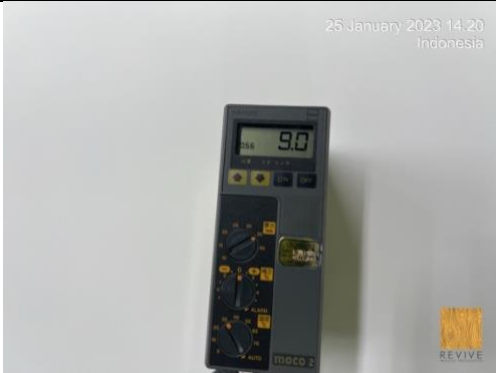
| Moisture Content | Moisture Content |

| Product | Specification | Actual Moisture Content (%) | | | Average (%) | Result |
|---|---|---|---|---|---|---|
| INTERIOR FLUSH DOOR<br>44 x 813 x 2438 | MC Product<br>(8-12%) | 10 | 9.5 | 9 | 9 | OK |
